Mold Remediation In An Air Handling System

Rodney H. Lewis, PE, Fellow ASHRAE
Rodney H. Lewis Associates, Inc.
Consulting Engineers
Houston, Texas

The Building

The Air Handling Units

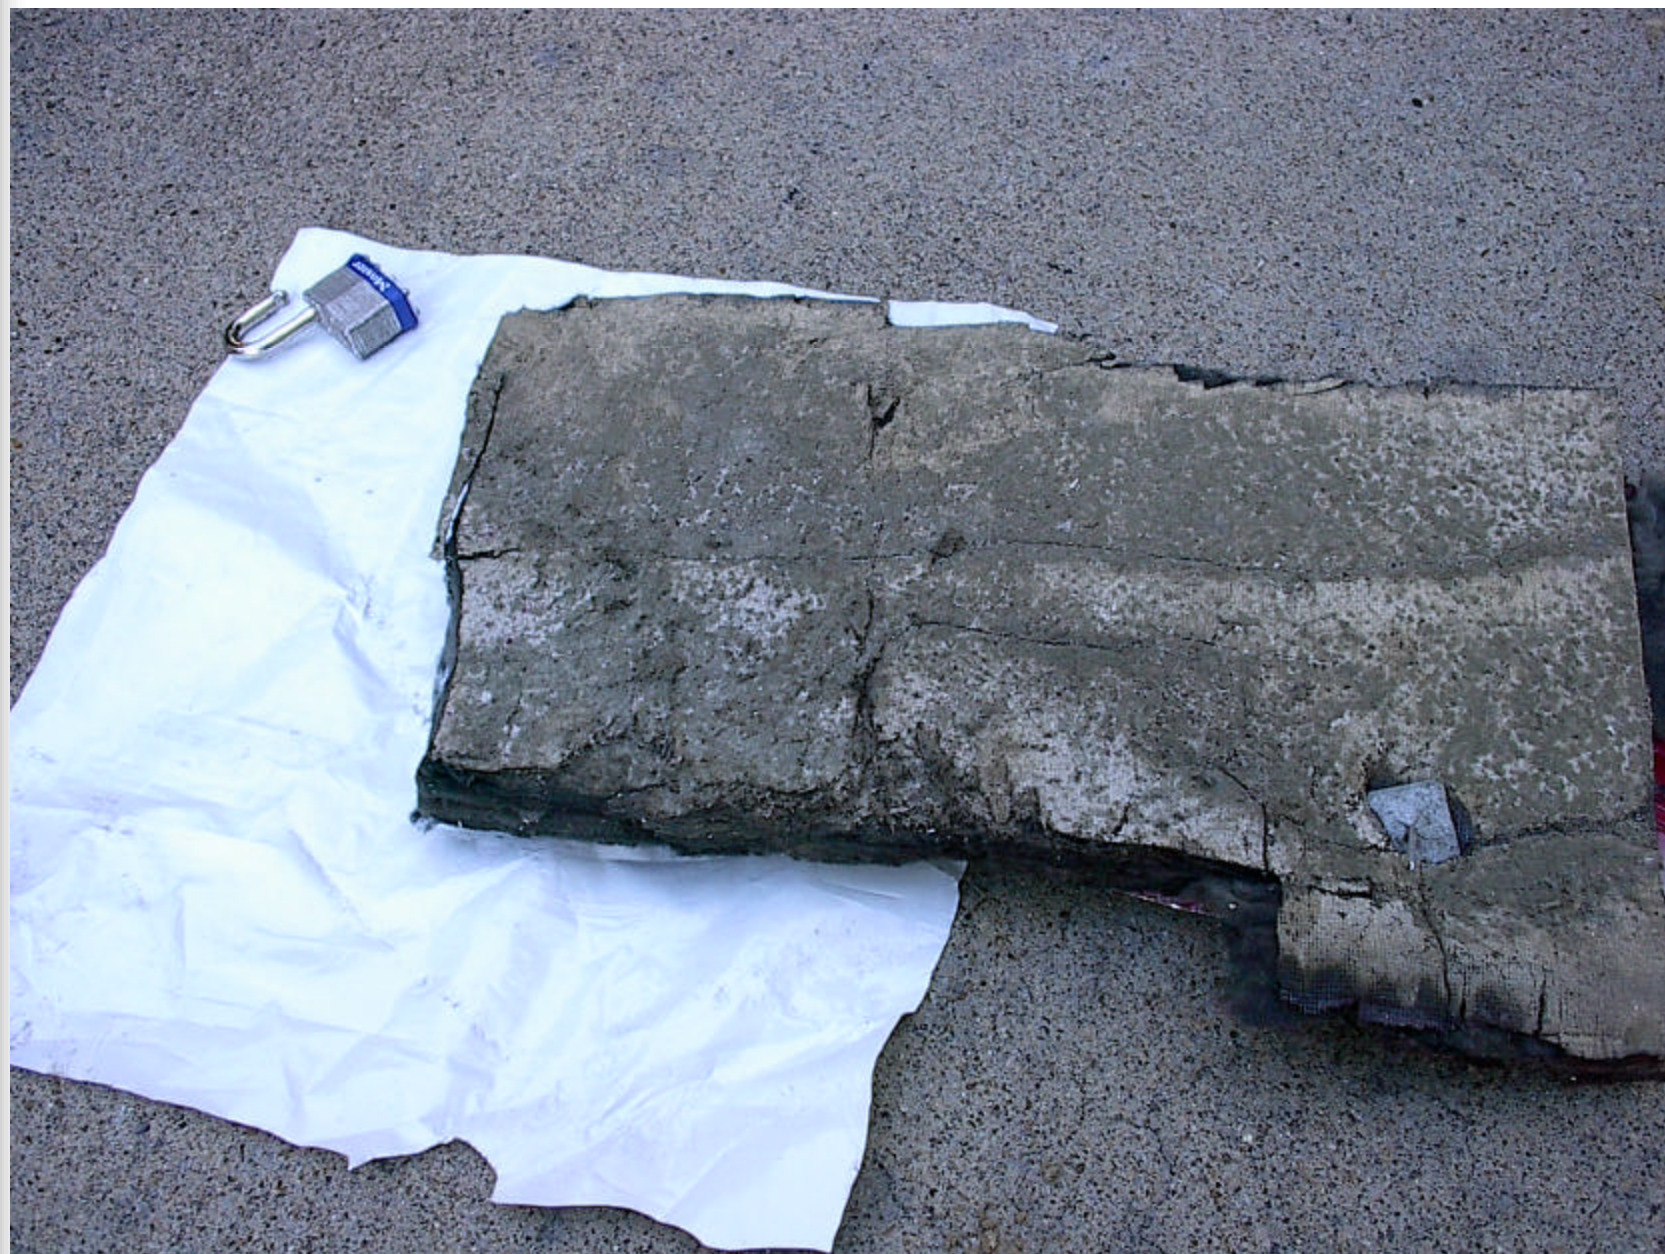
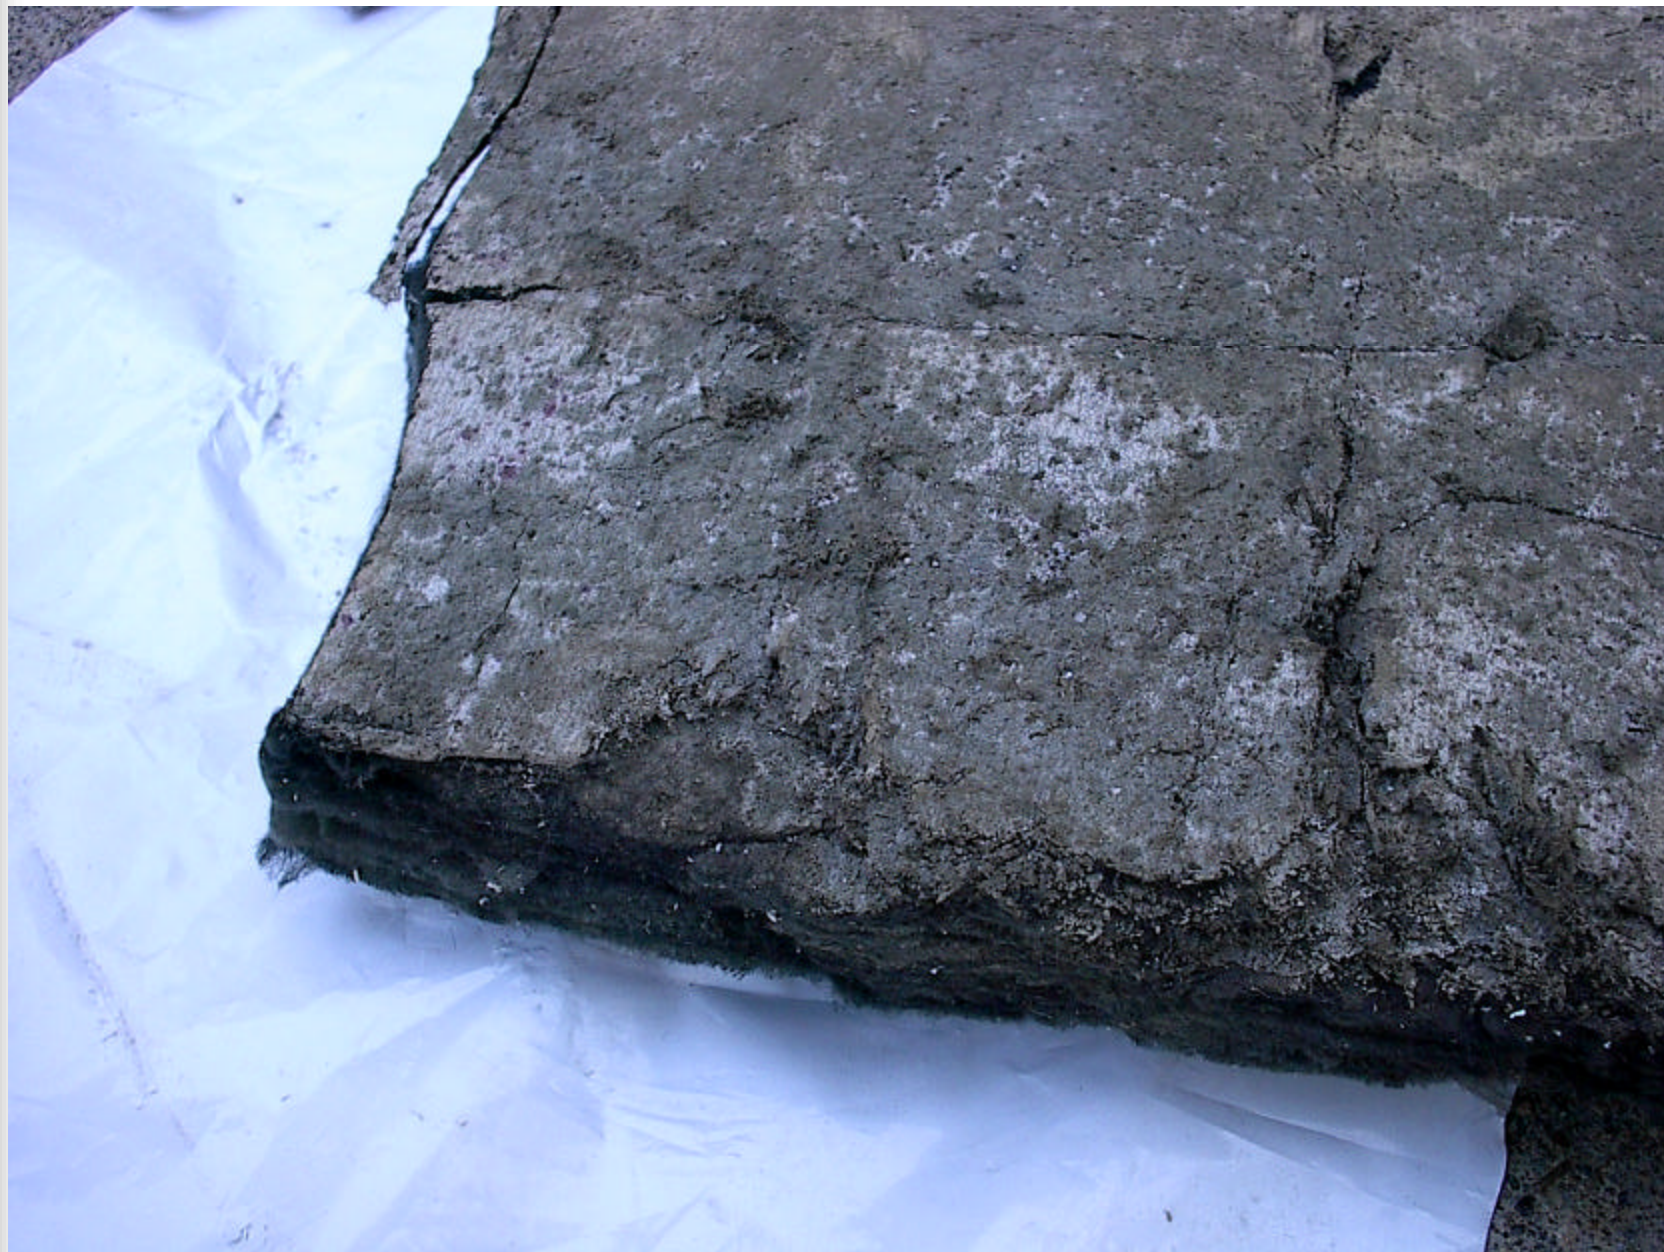
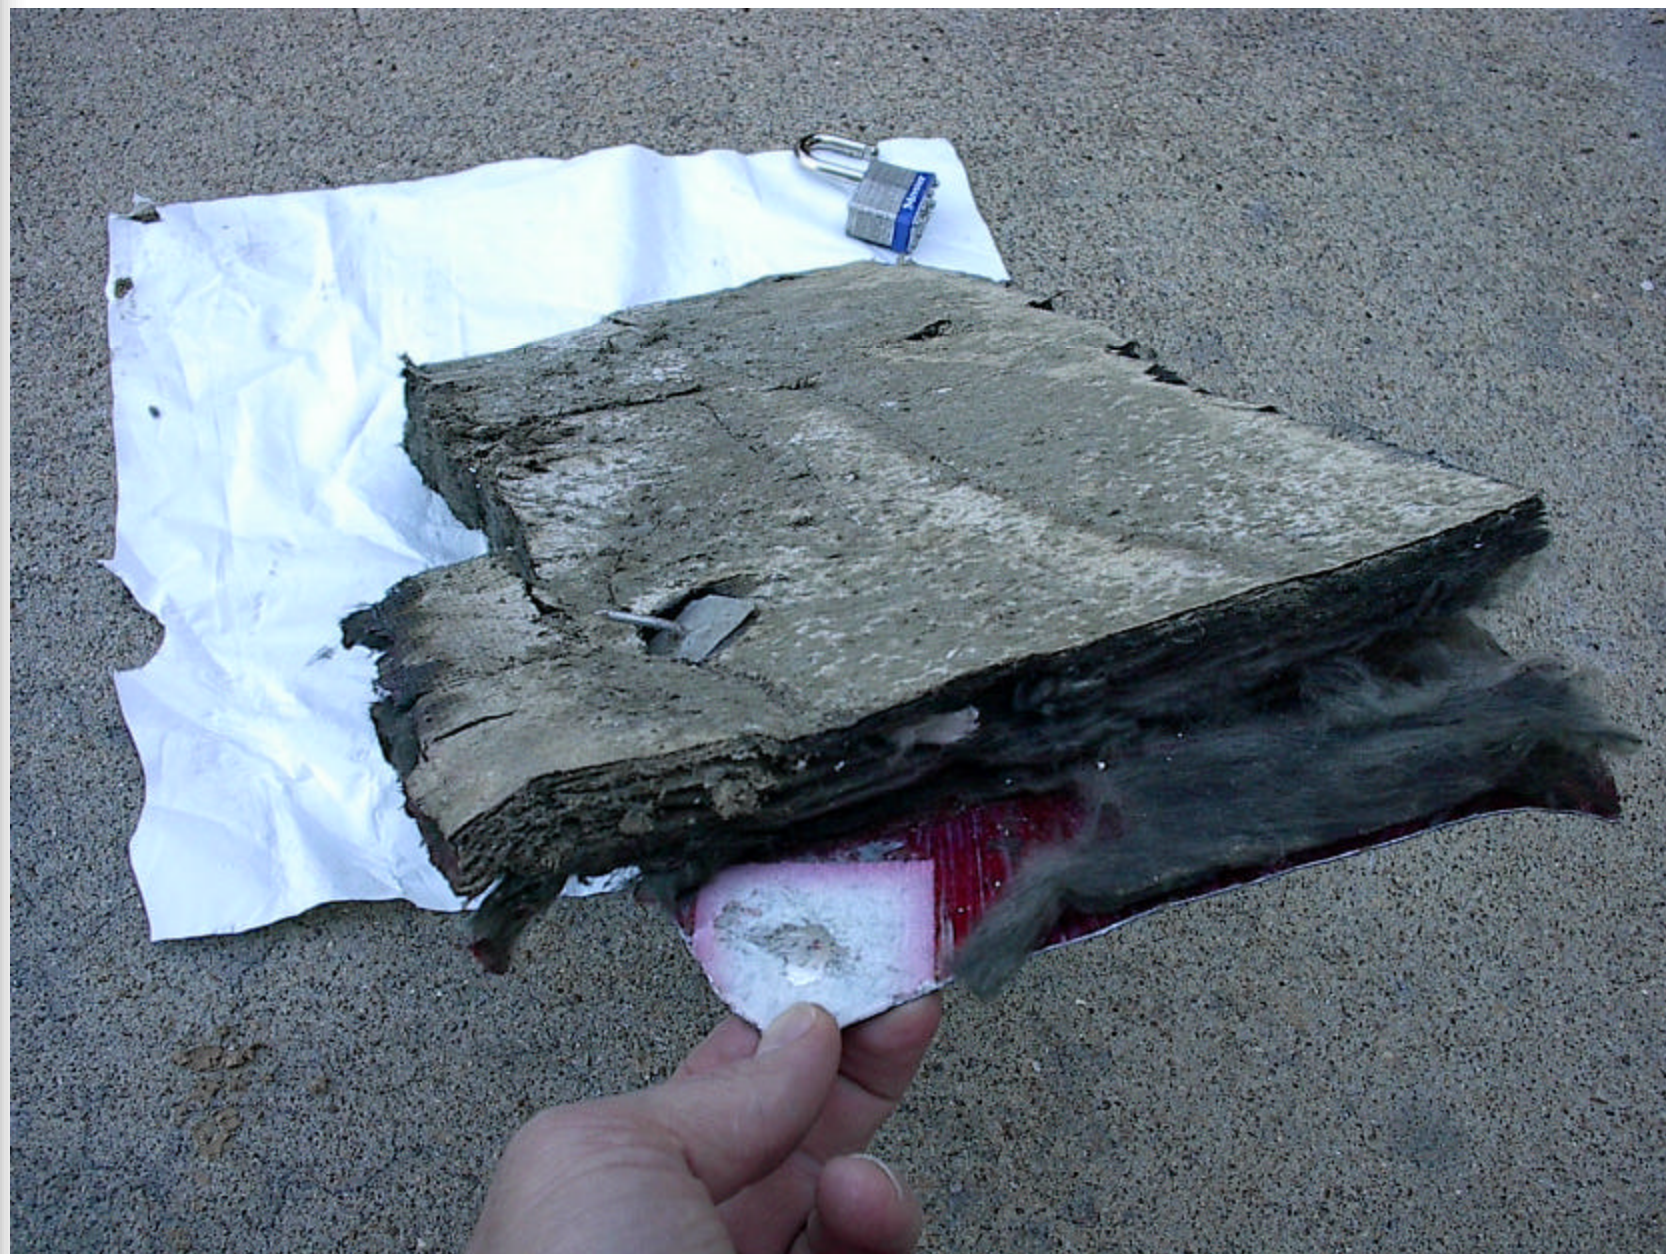
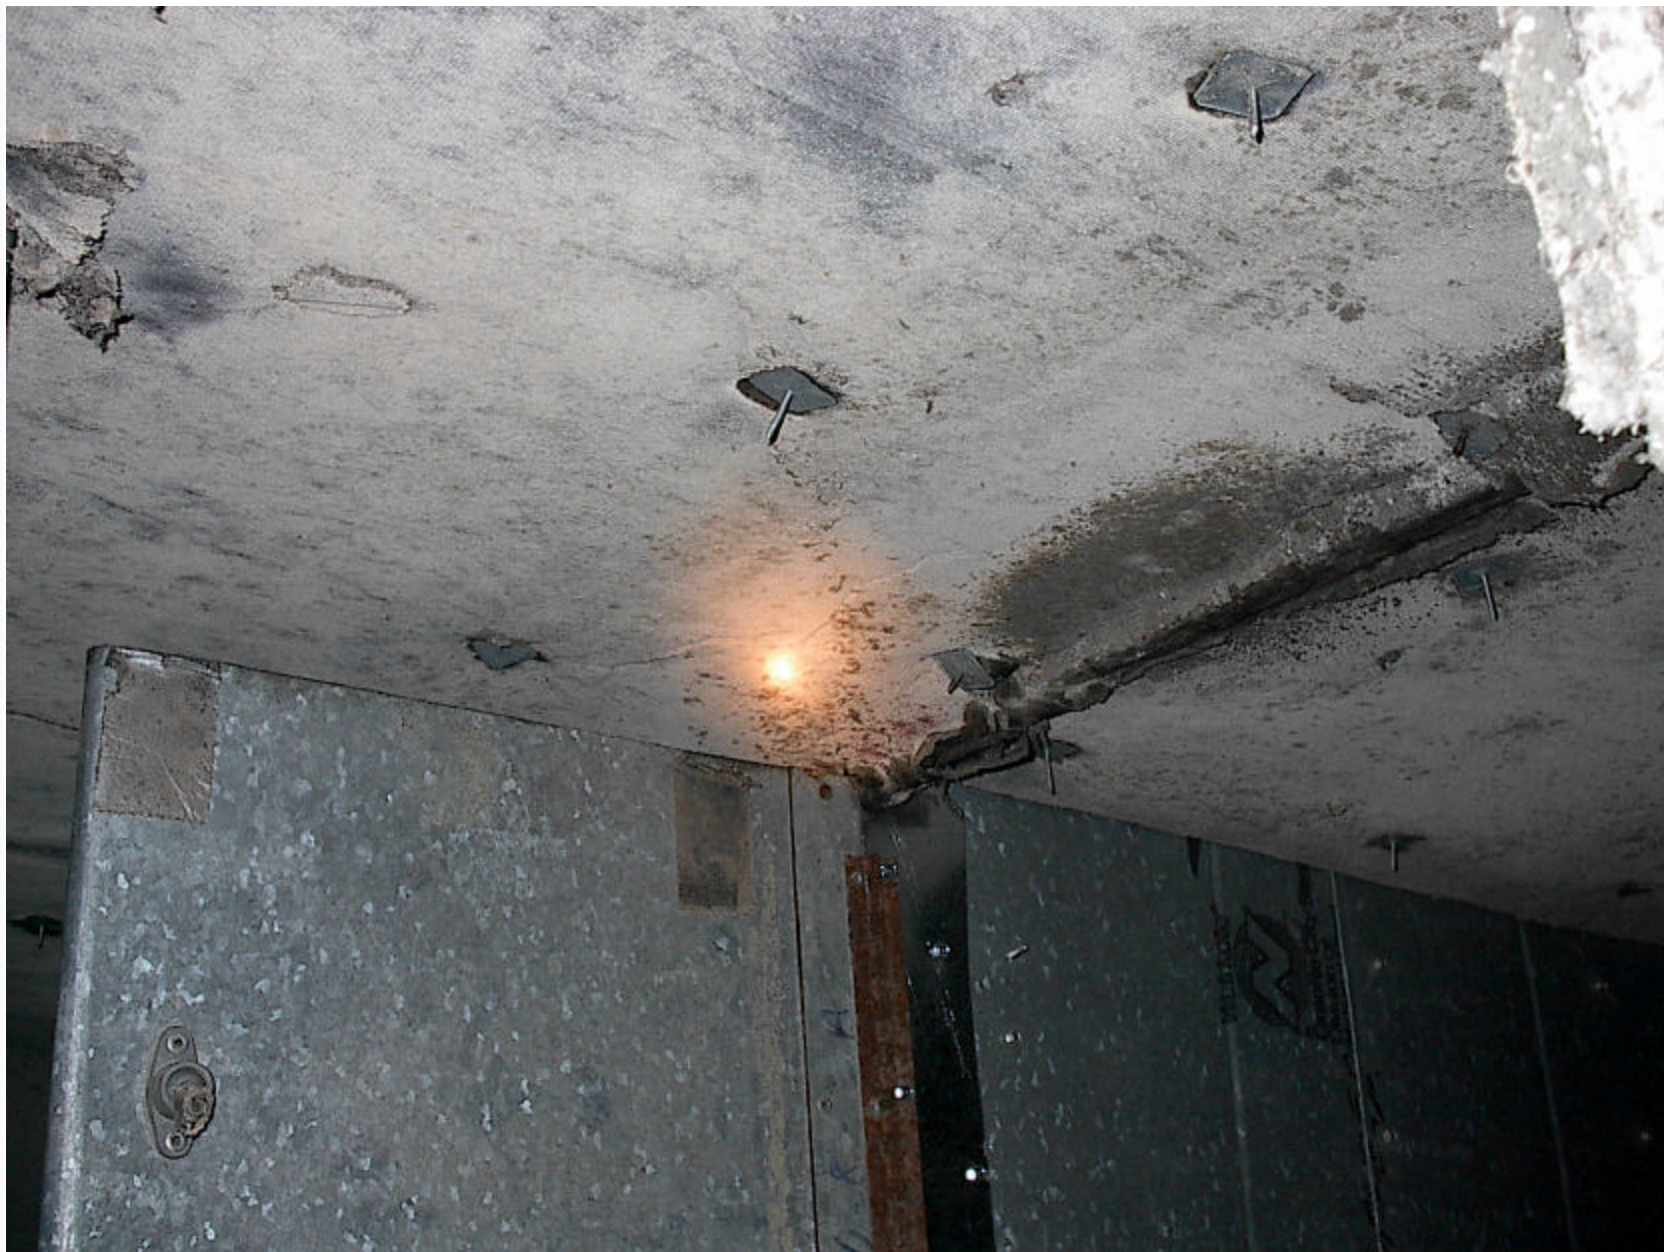
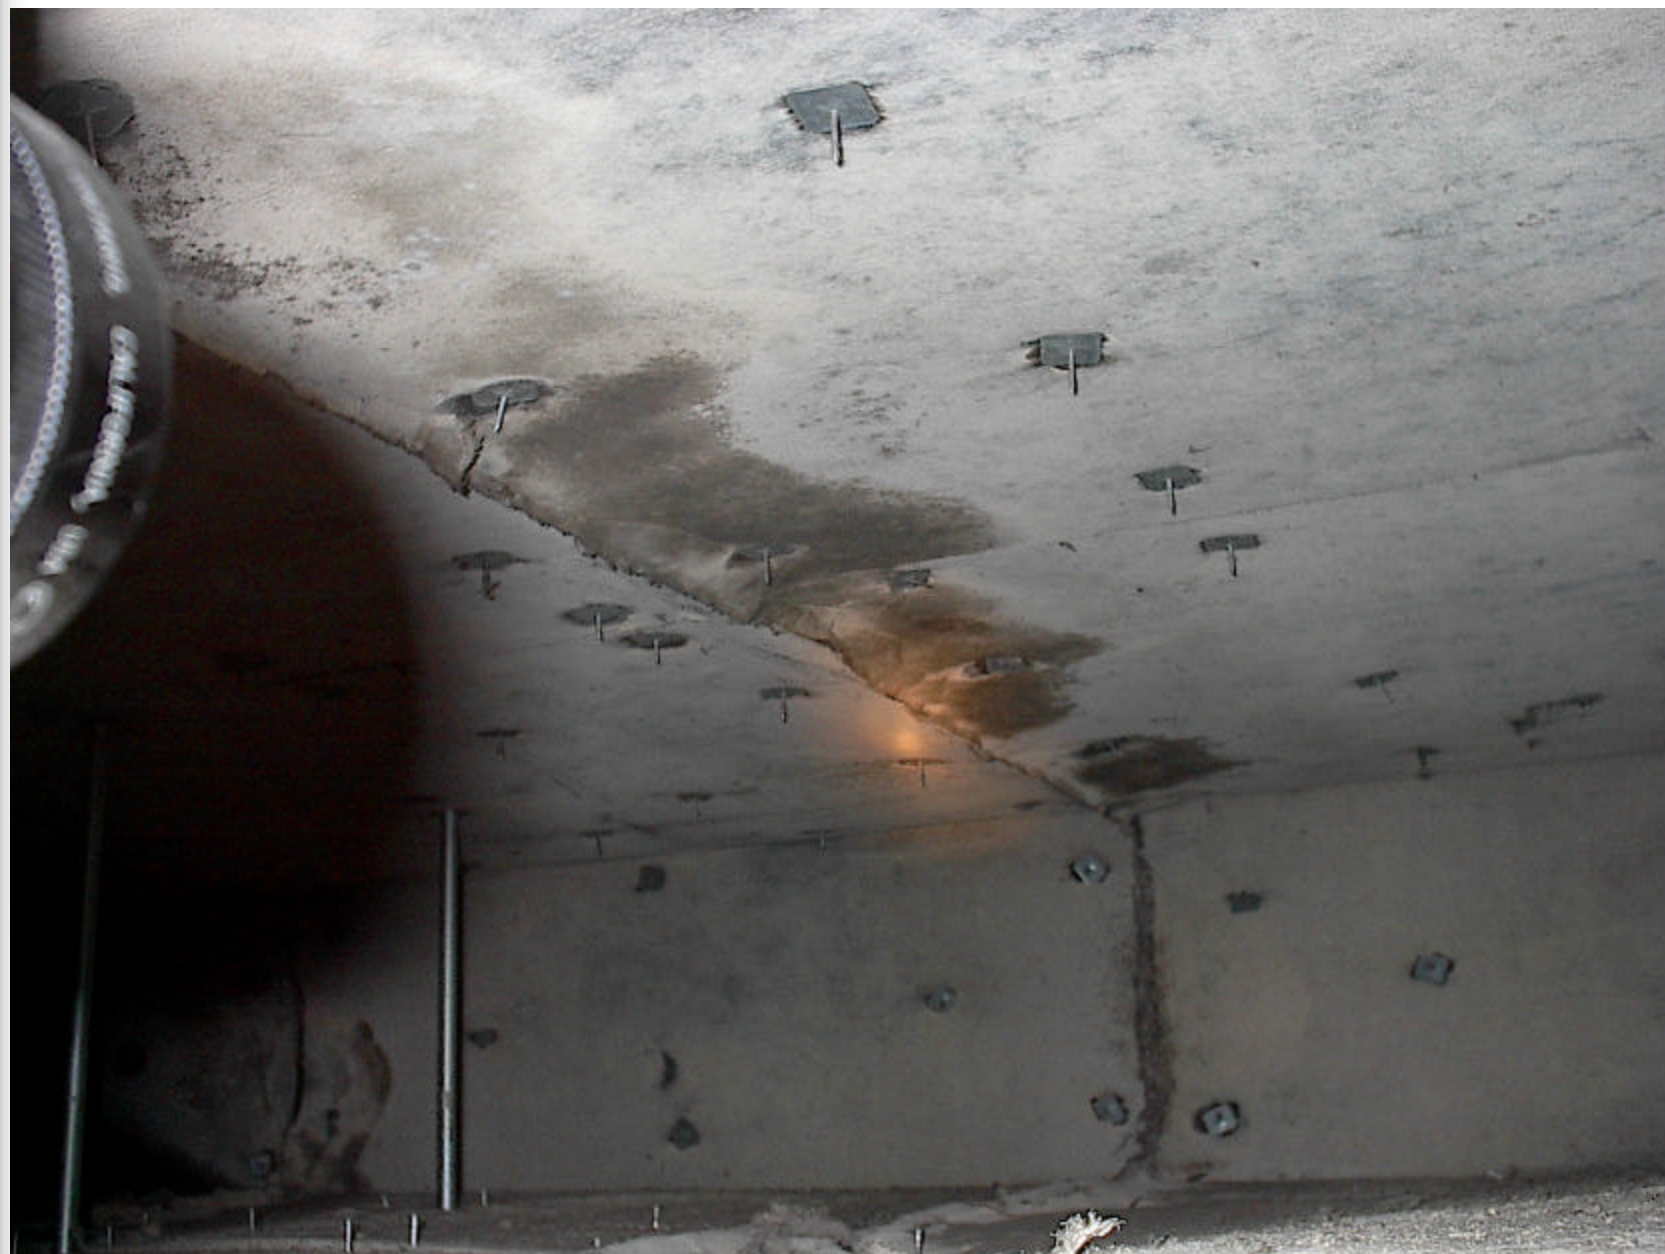
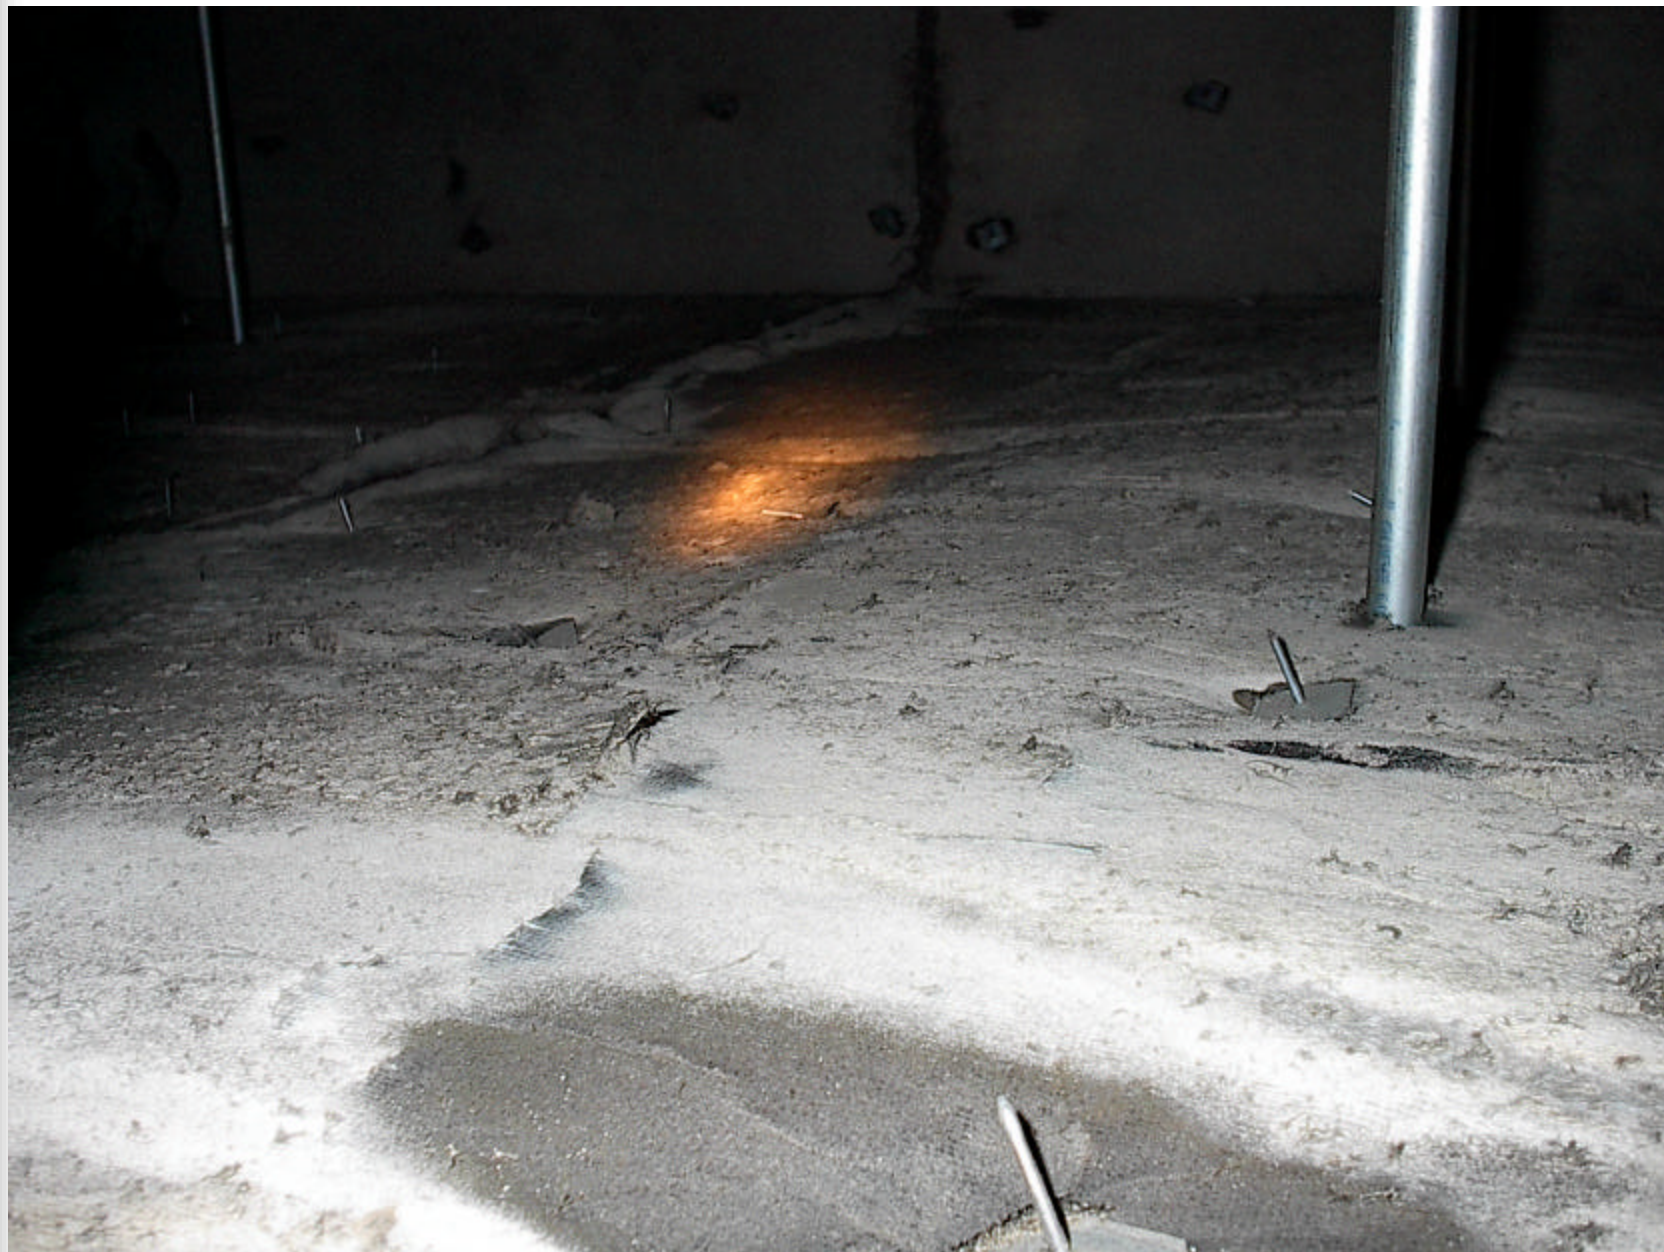
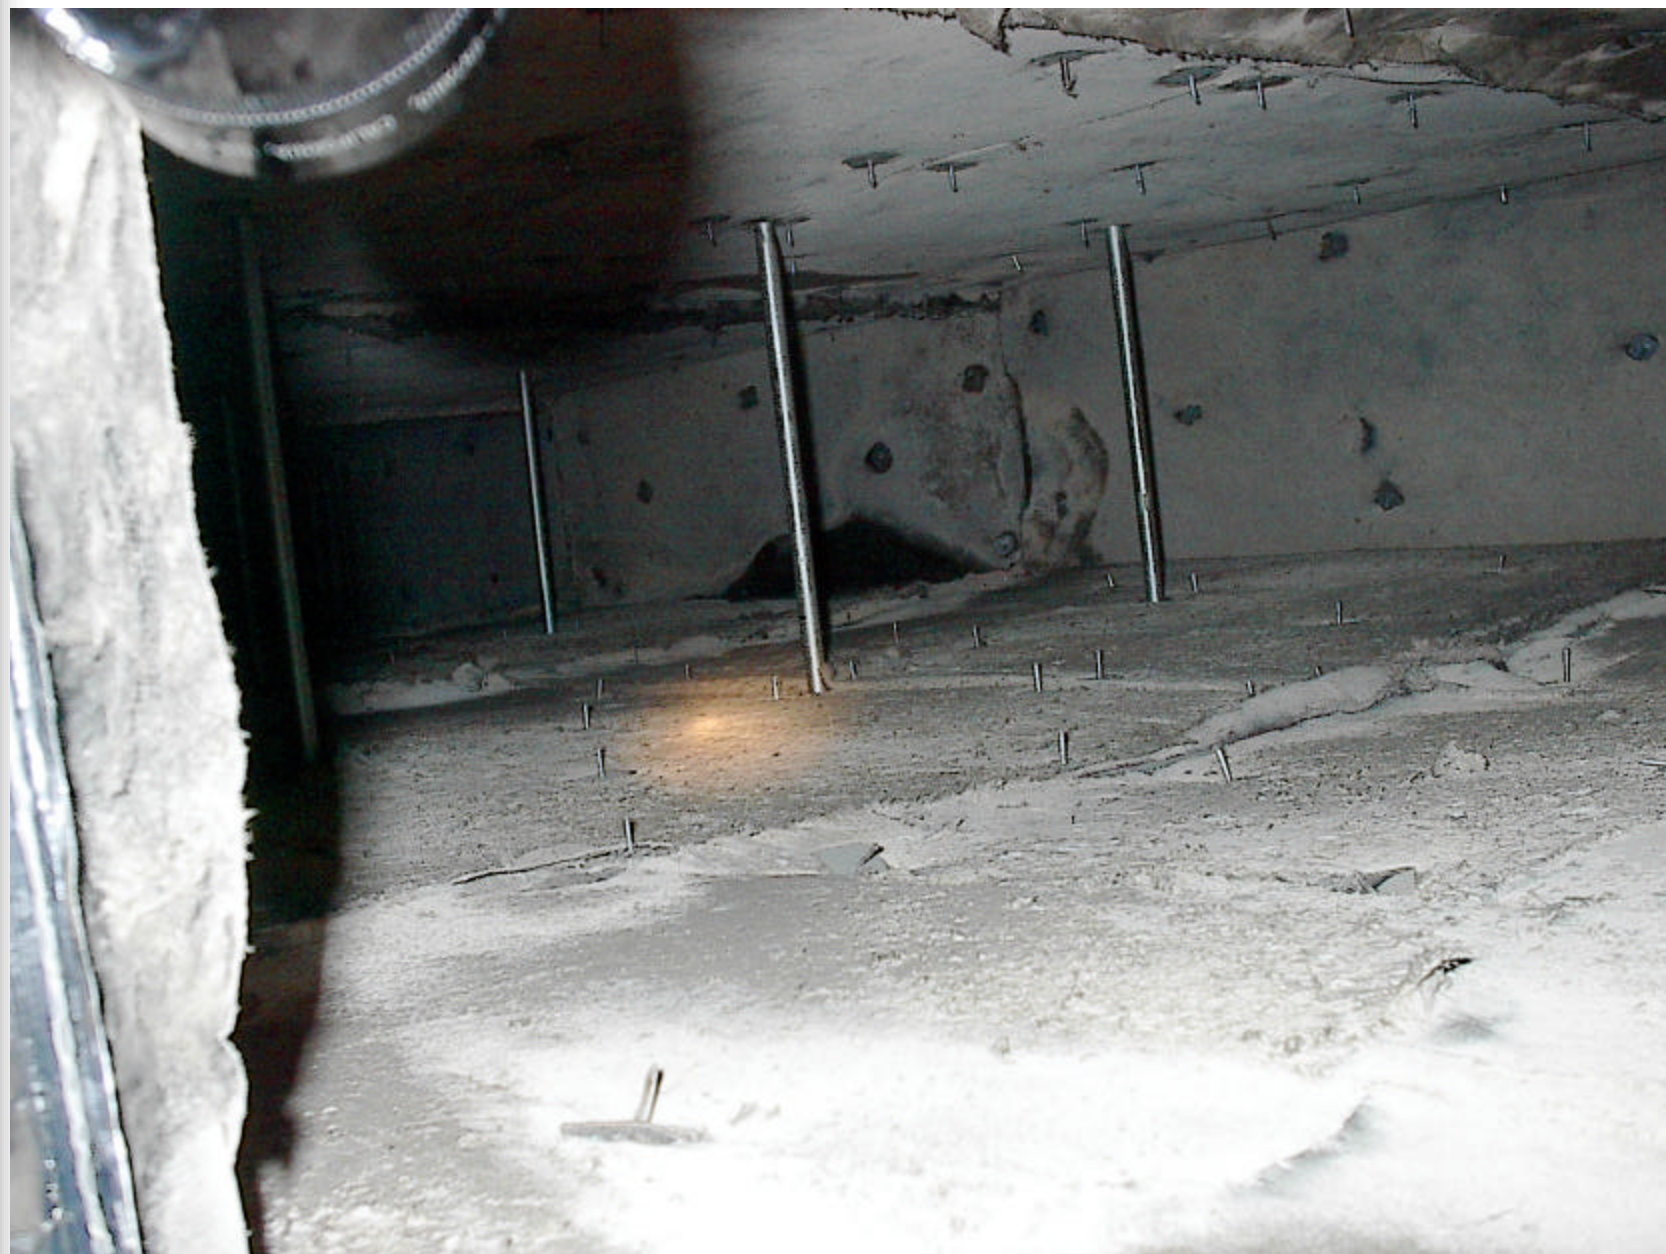
SIGNIFICANT ODORS IN COLD DUCT

SIGNIFICANT MOLD IN DUCT LINER AND AIR
HANDLING UNIT INSULATION

MOLD ON COIL AND DRAIN PAN

Probable Causes

CHILLED WATER VALVE MALFUCTION

HIGH COIL FACE VELOCITY CAUSING CARRY-OVER

DUCT WORK LINER WETTED DURING CONSTRUCTION

POOR MAINTENANCE

- MONITOR WITH PARTICAL COUNTER OUTSIDE CONTAINMENT THROUGHOUT PROCESS
- CUT ACCESS DOORS INTO UNIT
- MOVE ALL FURNITURE OUTSIDE OF REMEDIATION AREA
- HEPA VACUUM MECHANICAL ROOM
- REMOVE CEILING TILES AND GRID WHERE NECESSARY
- CREATE CONTAINMENT AREA WITH POLY SHEETS, FLOOR TO STRUCTURE INCLUDING COVERING CARPET

- REMOVE AND BAG DUCTWORK AND UNIT INSULATION
- HEPA VACUUM INSIDE UNIT AND ENTIRE CONTAINMENT AREA
- APPLY DISINFECTANT TO ALL SURFACES
- REMOVE CONTAINMENT

- UNIT INSULATION – DUCTBOARD WITH FOIL FACING TO AIR STREAM
- NEW DUCTWORK FOR BOTH HOT & COLD DUCTS
- ALL DUCT JOINTS SEALED
- EXTERNAL DUCT INSULATION
- SLOW FAN TO 550 FEET PER MINUTE COIL FACE VELOCITY
