Laboratory Evaluation of Residential Window Installation Methods in Stucco Wall Assemblies

- > ASHRAE Meeting
January 29, 2007
Dallas, TX

Neil P. Leslie, P.E.
Gas Technology Institute
847 768 0926
neil.leslie@gastechnology.org

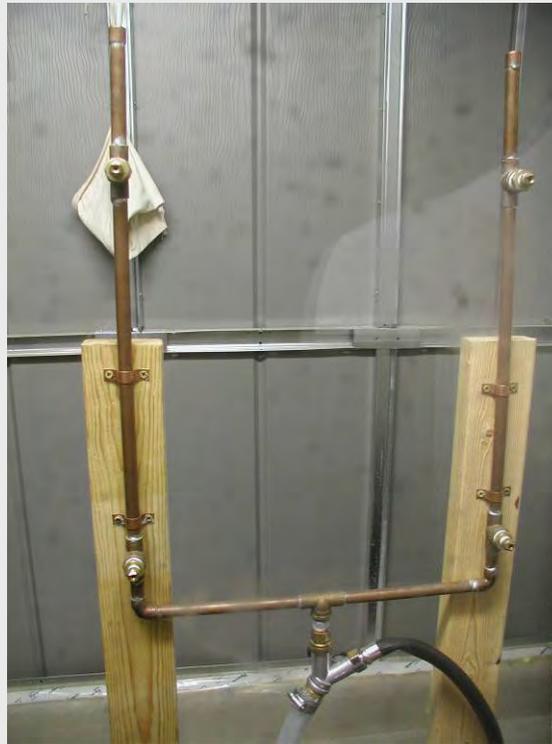
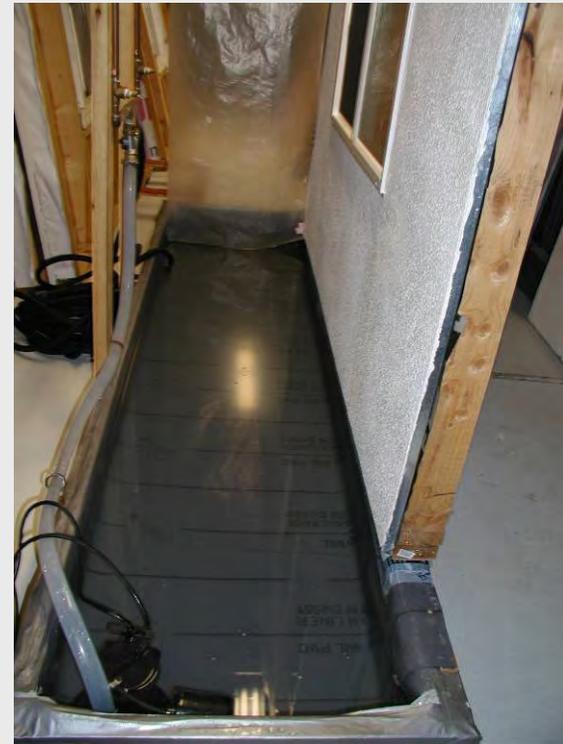
Spray Rig Setup

> Water Spray Tests

- Spray entire window/wall assembly
- 15 minute spray typical, extended duration to meet goals
- Local spray and water pour tests on targeted assemblies
- No air pressure or temperature differential

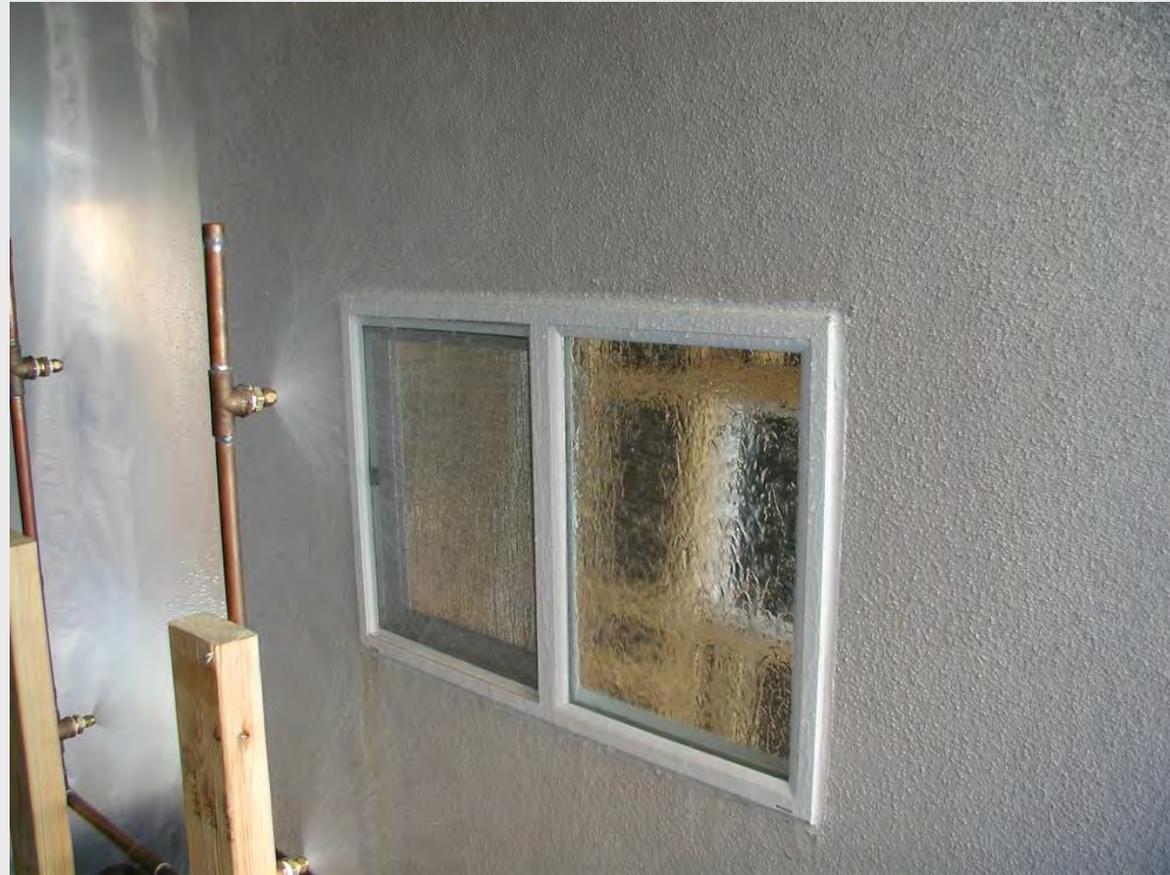
Spray Test with Stucco and Caulk Applied (Full Barrier)

Spray Test on Stucco with Freshly Caulked Window Frames

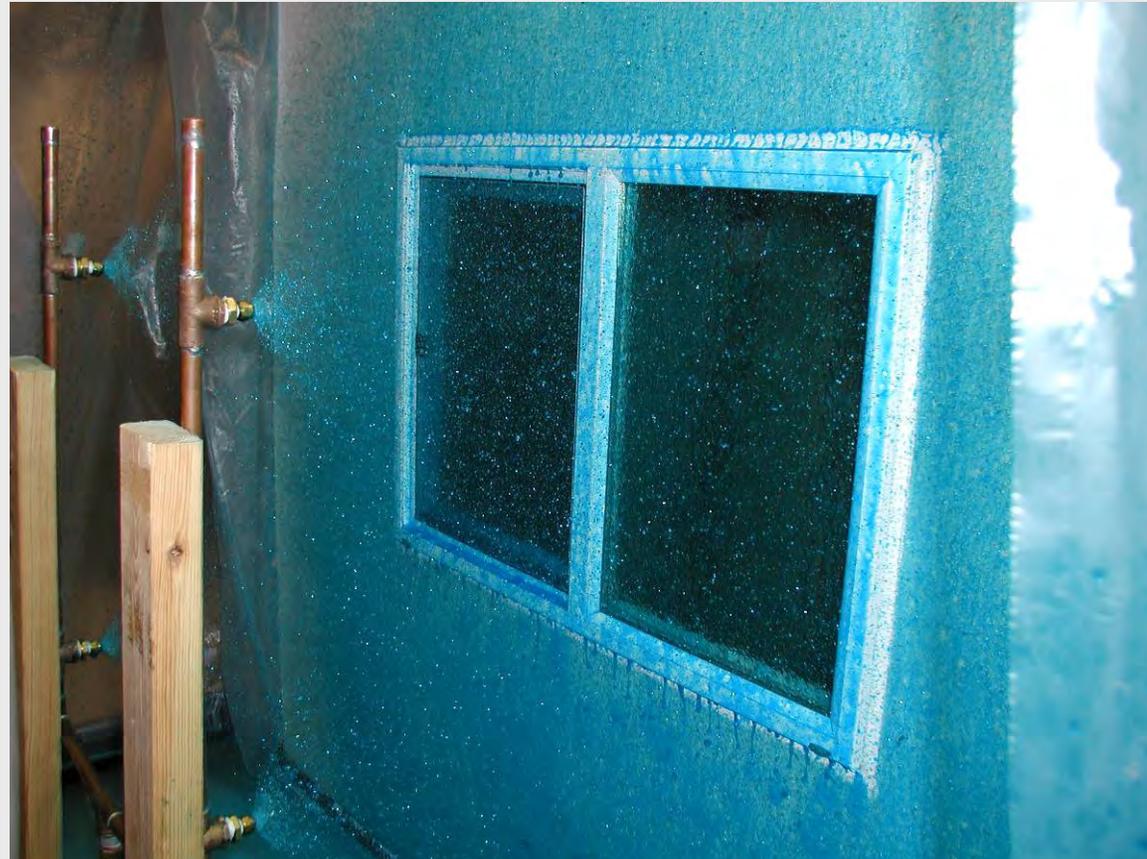
Spray Test with Dyed Water

Dyed Water Spray Test for Assemblies with OSB Sheathing
To Identify Hidden Leaks After Destructive Disassembly

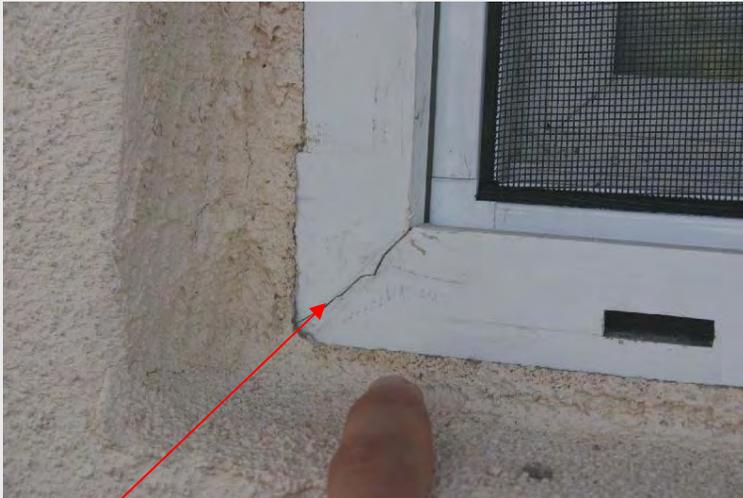
Cracked Window Frame in New Home Simulated in Lab

Cracked Window Frame in New Home

$\frac{1}{8}$ " Drilled Holes at Flange Welds to Simulate Cracked Flange

Typical Site of Window Frame Leak in Field and Laboratory Simulation Using $\frac{1}{8}$ " Drilled Holes

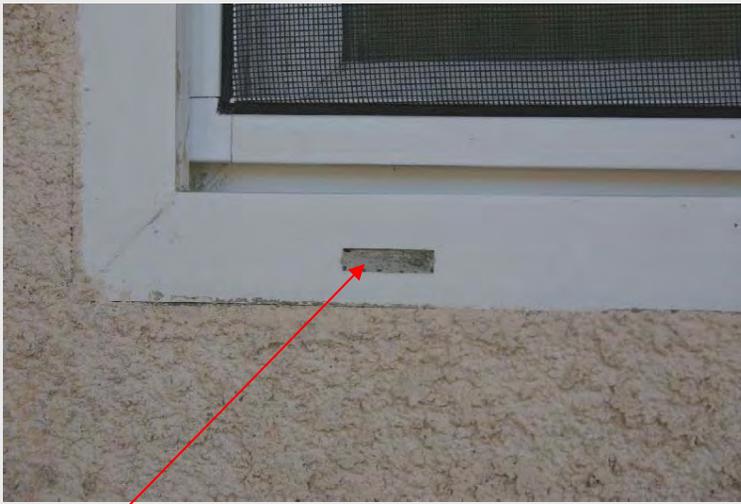
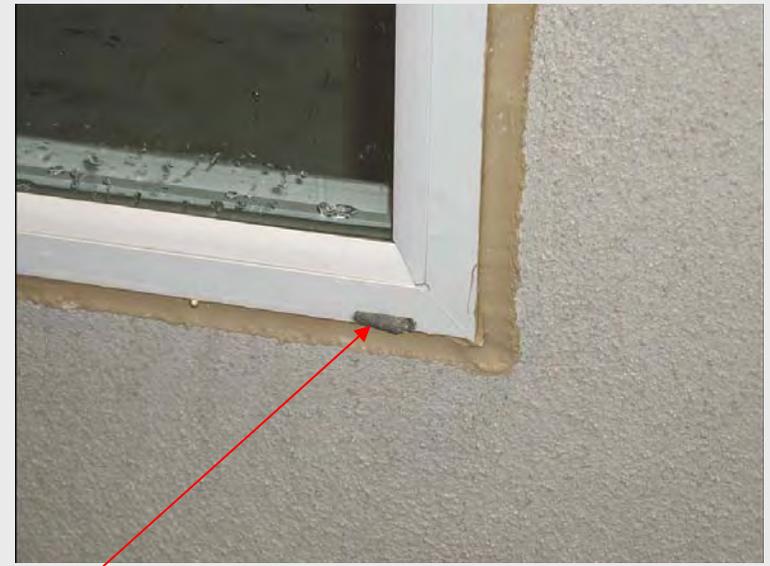
Plugged Weep Hole in New Home Simulated in Lab

Weep Hole Plugged with Stucco in New Home

Plugged Weep Holes in Lab to Provide Head Pressure

Typical Site of Plugged Weep Hole in Field and Laboratory Simulation Using Foam Inserts

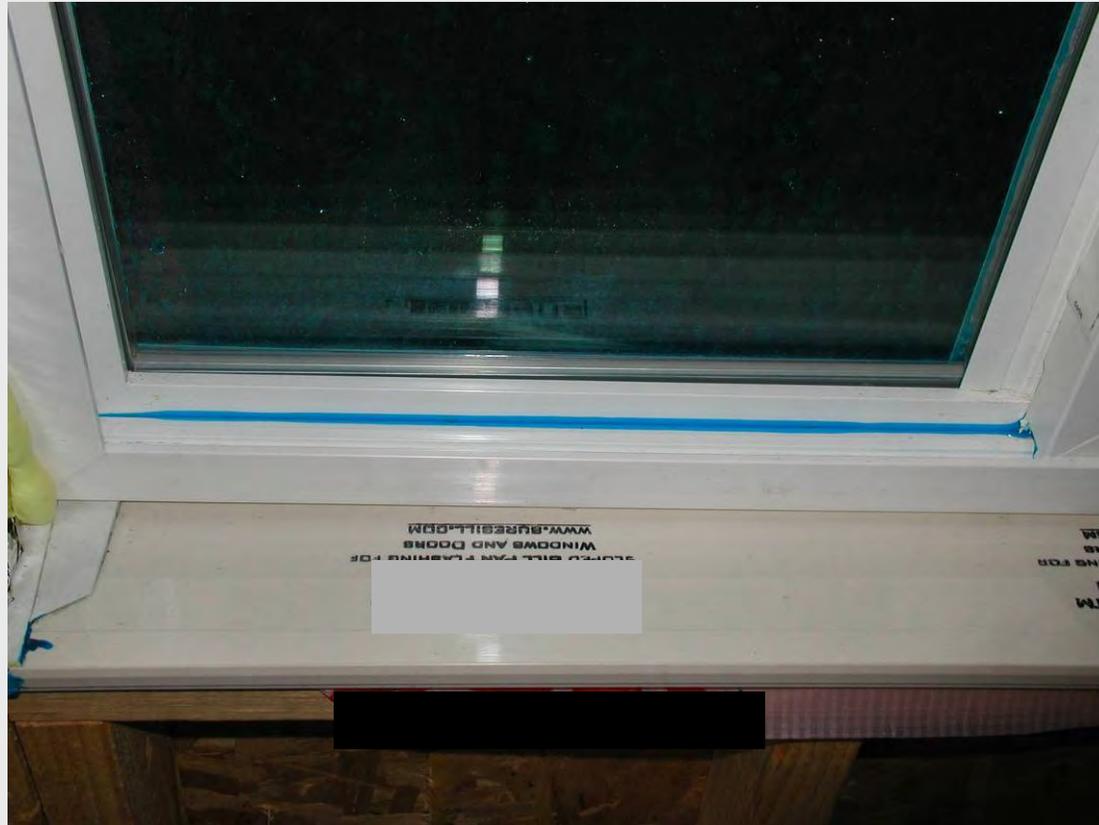
Dyed Water Experiment, Weep Holes Open

Water on Interior Track Through Brush Gasket is “Normal”
and Drains to Outdoors Through Weep Holes

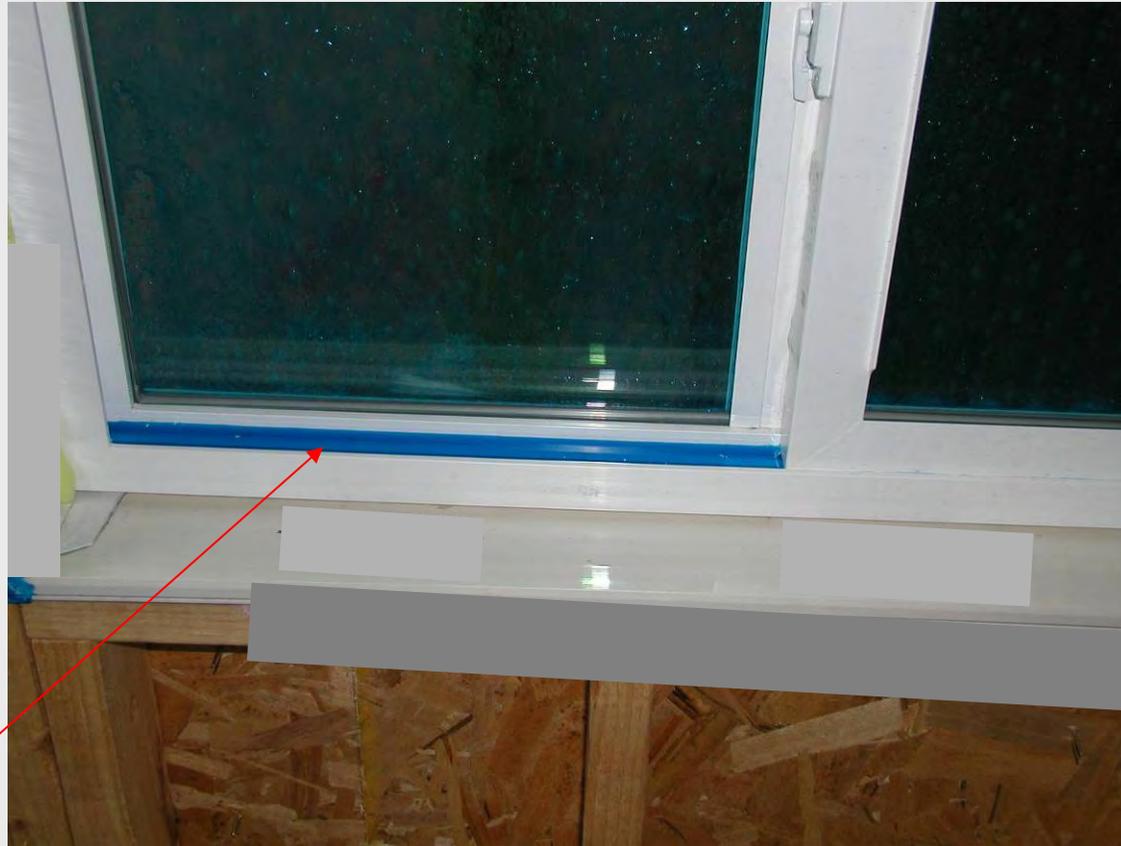
Dyed Water Experiment, Weep Holes Plugged

Abnormal Water Level in Track Shows Head Pressure for Greater Flow Through 1/8" Holes with Weep Holes Plugged

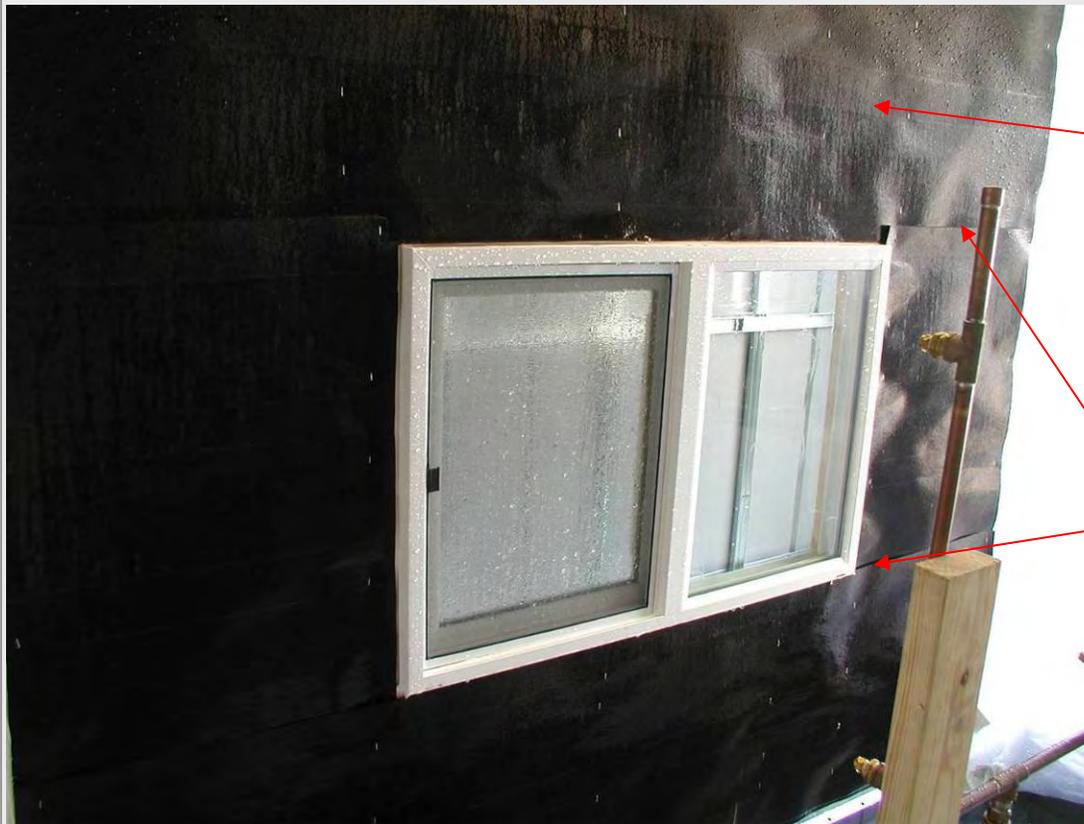
Reverse Shiplap Construction Before Stucco Application

2-Ply Building Paper Ineffective with Reverse Shiplap

Reverse Shiplap Drains Water to Interior of Wall

Significant Leakage Behind 2-Ply Reverse Shiplap WRB Before Stucco Application with Gravity-Dominated Drainage

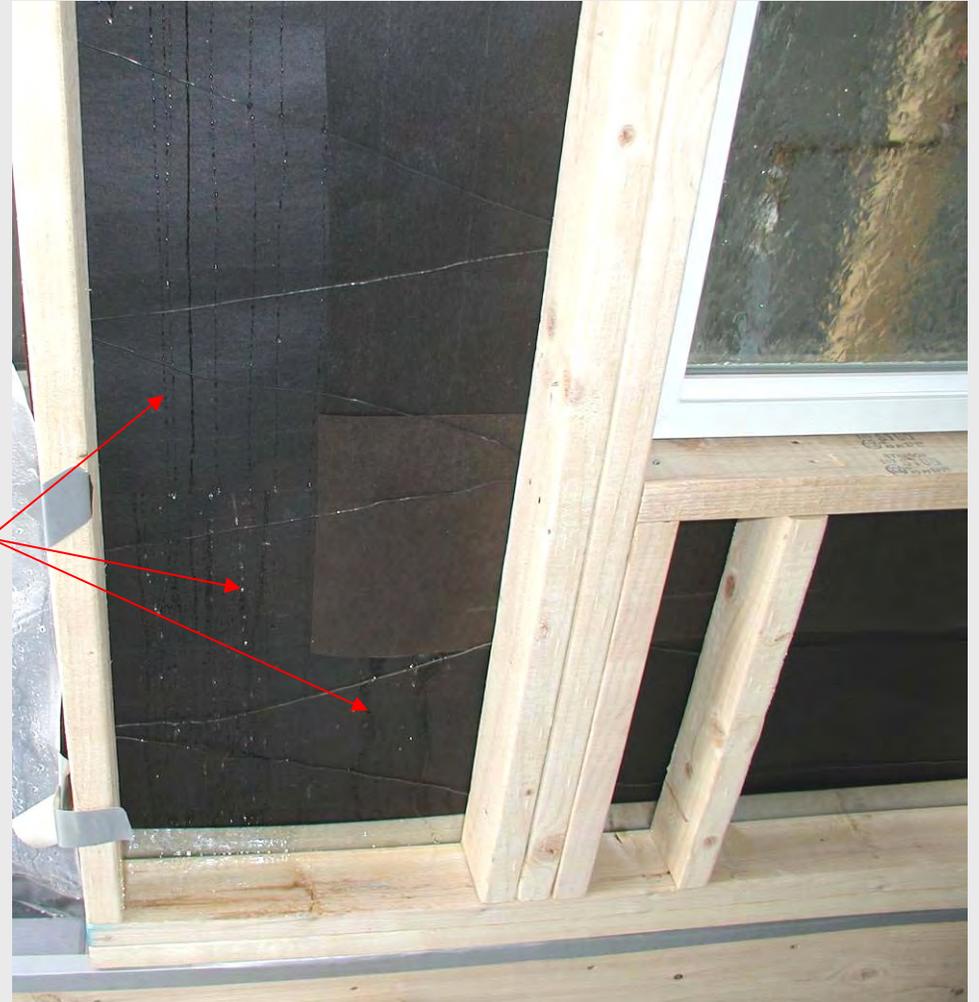
Leaks at Reverse Shiplap Before Stucco Application

Numerous Rivulets On
Interior Side of 2-Ply
Paper with Leaks Due
to Gravity Drainage

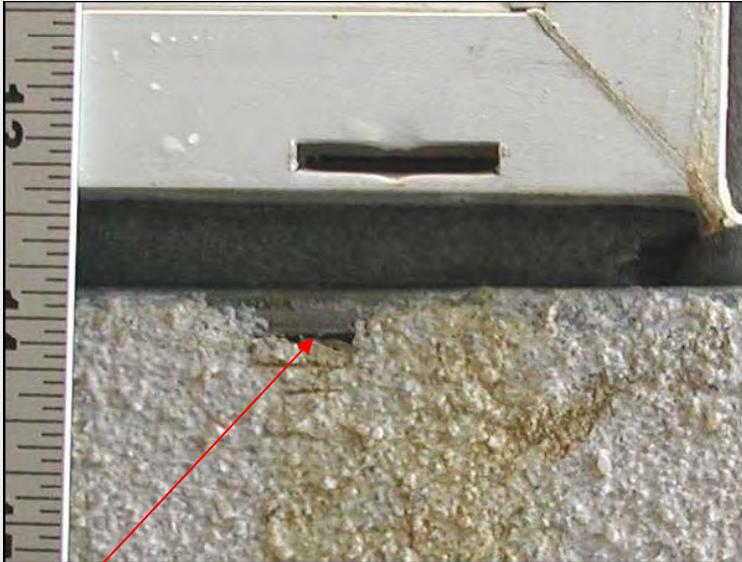
Leak at Stucco Flaw

Stucco Flaw Beneath Window Frame

Resulting Leak Through Small Hole in WRB

Bulk Water Flow Through Stucco Flaw, Coupled with Small Hole in WRB, Resulted in Leak at Sill

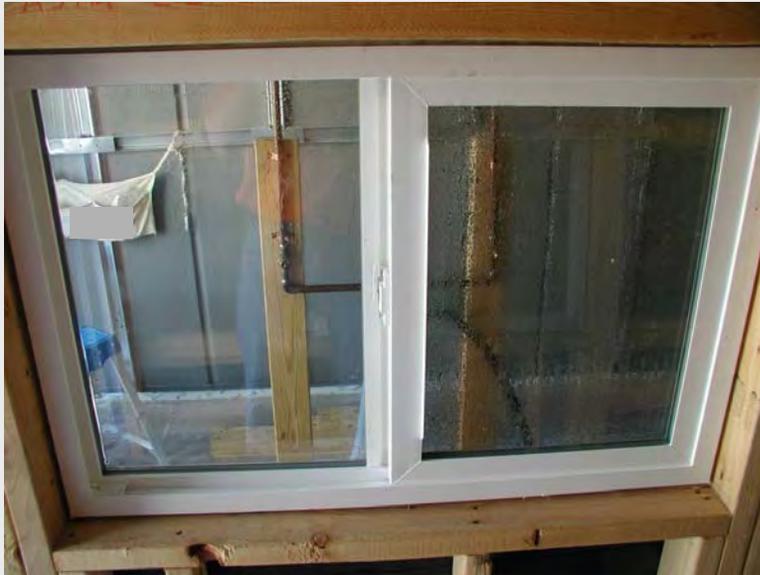
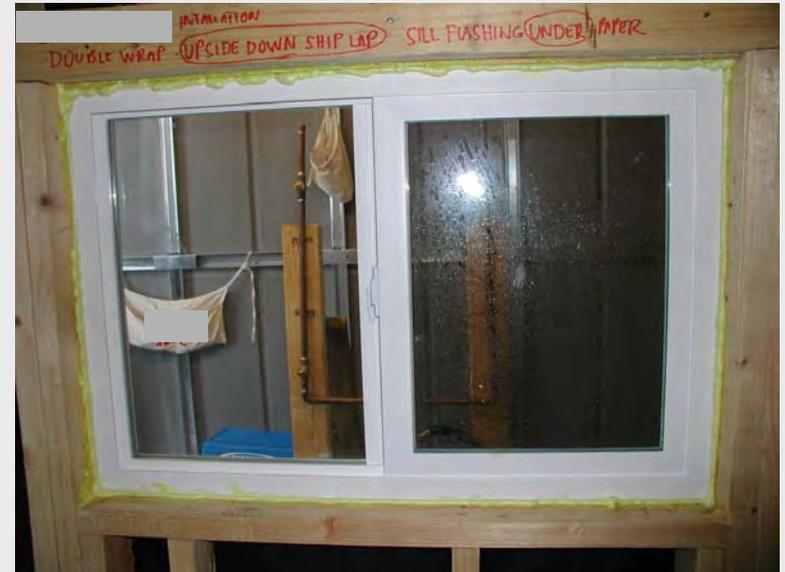
No Leak with Stucco Cladding and Caulk for Full Face Seal

Stucco cladding and caulked frame provide full seal

Effective even with reverse shiplap 2-ply building paper

Stucco Cladding with Caulk Stops Bulk Water Flow. Capillary Suction Transports Moisture to Interior Side of Stucco

- > Stucco Drainage Mechanisms Impacted WRB Drainage Capacity and Leak Risk
- > Weep Screed/Stucco Interface Substantially Reduced Gravity Drainage Capacity
- > Stucco with Drainage Channels and EIFS with Designed Drainage Had Much Higher Drainage Capacity
- > Stucco with Freshly Caulked Window Frame Prevented Liquid Water Penetration At Window/Wall Interface, Even With Reverse Shiplap

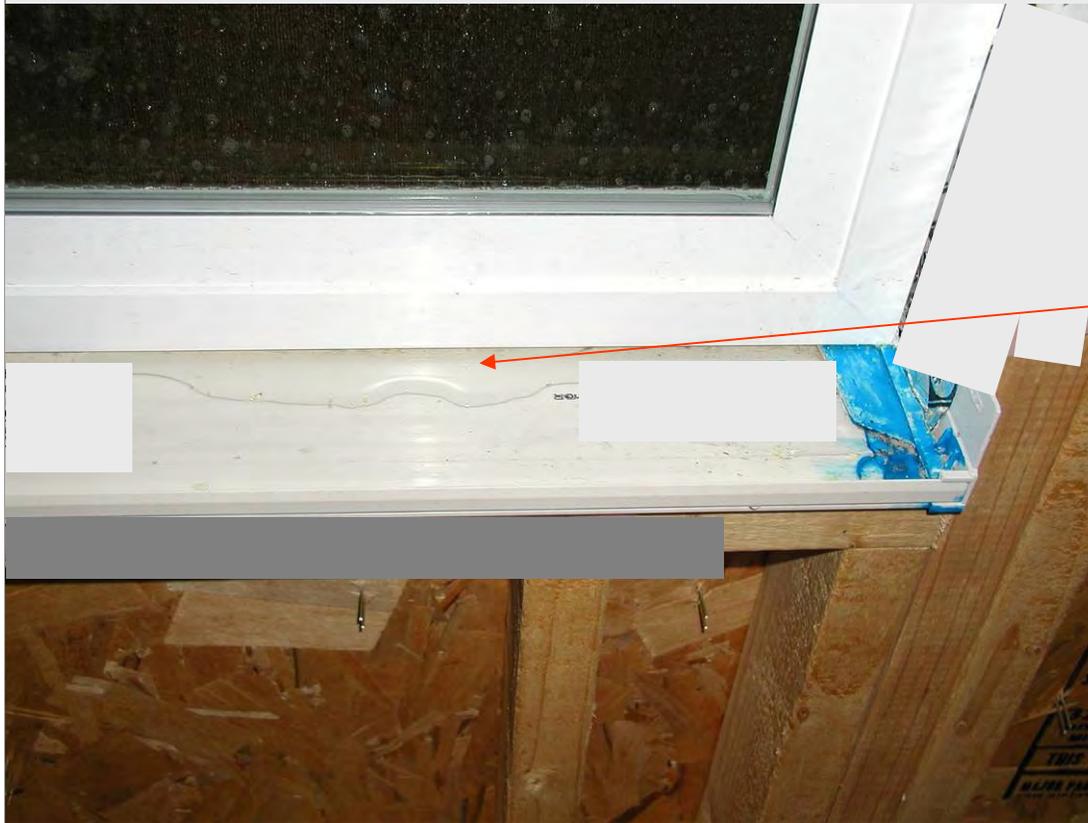
Drilled 1/8" Hole Experiment, Weep Holes Plugged

Water In Sill Pan
From Leak Under
Head Pressure
Through 1/8" Hole
Drilled In Window
Frame, with Weep
Holes Plugged

Sill Pan Effectively Collected Water Leaking Through Window Frame

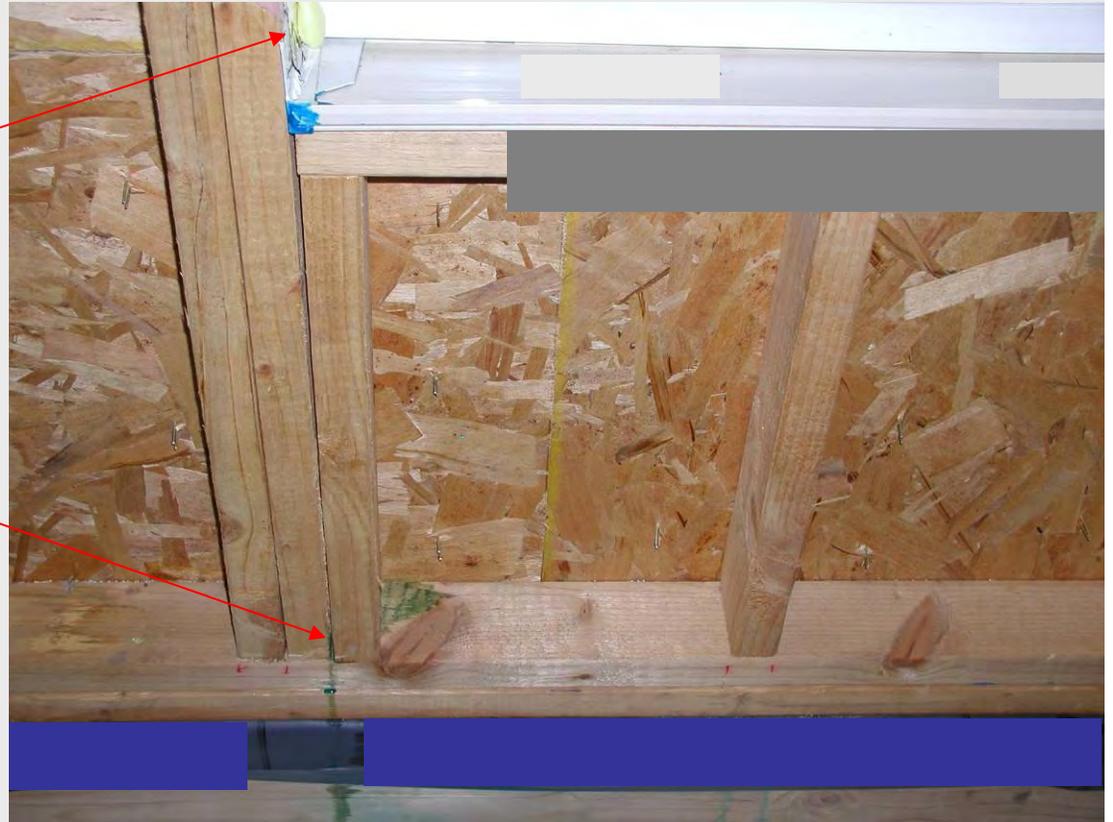
Leakage with Sill Pan and OSB Sheathing

Leak Point of Origin
at Junction of Sill
Pan, Stucco, and
WRB

Dyed Water Shows
Visible Leakage
Between Studs on
Interior Side of OSB

Leak to Interior Side of OSB Sheathing Due to Capillary-Dominated
Drainage and Head Pressure from Water in Sill Pan

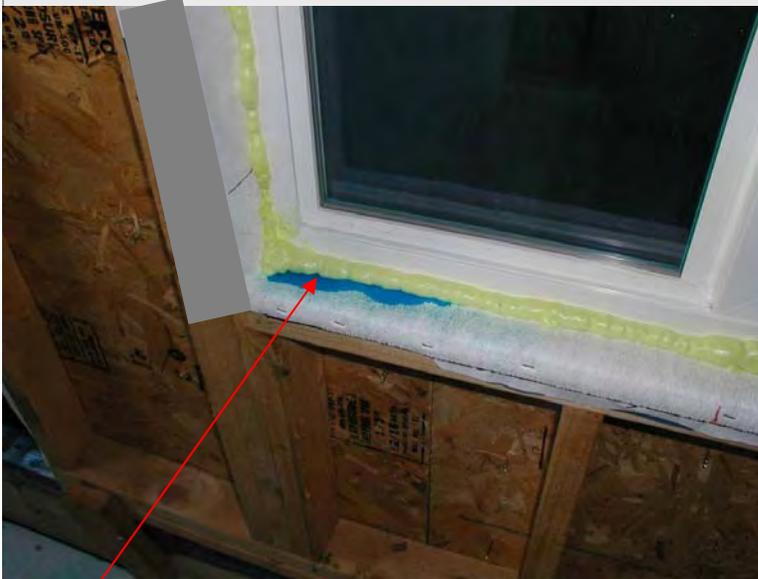
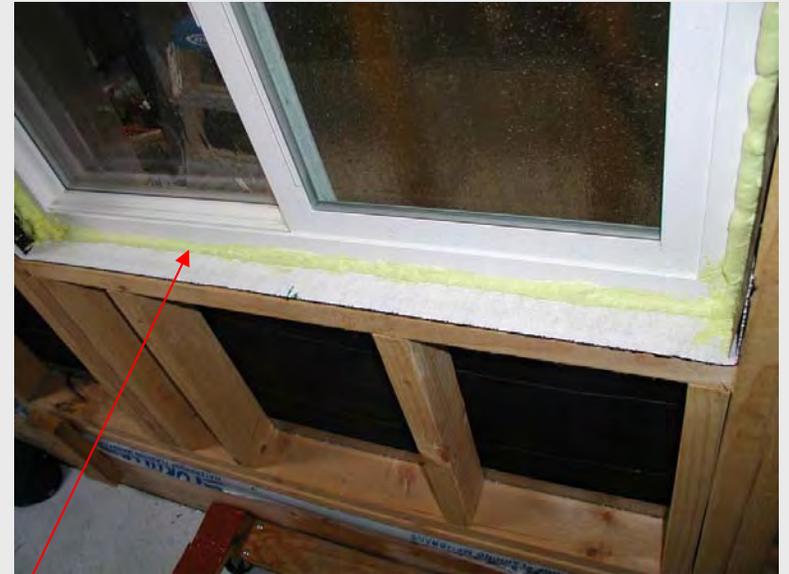
Leak with Foam Sealant Due to Misapplication/Incompatibility

Foam Sealant Did Not Contain Leak in This Case

Foam Sealant Contained Leak in This Case

All Stakeholders Involved in Design and Installation Need to Ensure Compatibility of Materials for Intended Use

- > WRB Drainage Capacity Impacted Sill Pan Performance
- > Low Pressure Expanding Foam Sealant (an Air Barrier) Contained Leaks at Sill When Full Seal Was Achieved
- > Foam Sealant Did Not Reliably Seal at Sill When Misapplied or Incompatible with Substrates
- > Perforated Housewrap Leaked Through Perforations With and Without Stucco Cladding

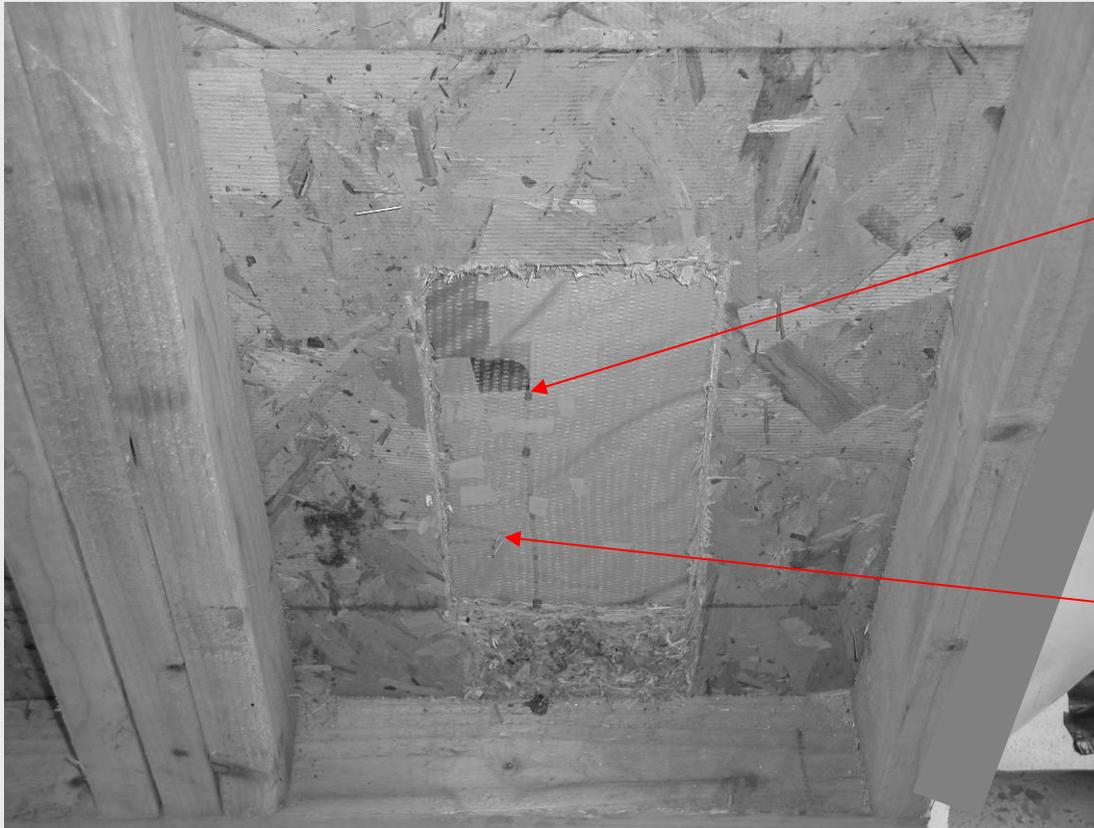
Dyed Water Leak
Through Perforated
Housewrap After
Stucco Application

No Leakage
Occurred at Staple
Penetration

Leak Through Perforated Housewrap Occurred Away From
Staple Penetration, with Capillary-Dominated Moisture Transport
