Long-Term Commercial GSHP Performance

Part 6: Maintenance and Controls

By **Steve Kavanaugh, Ph.D.**, Fellow ASHRAE; and **David Dinse**, Member ASHRAE

This article is the sixth in a series summarizing a data collection and analysis project to identify common characteristics of successful ground source heat pump (GSHP) systems.¹ This article presents results from maintenance personnel assessments of GSHP including controls. Occupant perception of maintenance responsiveness and controls also are provided.

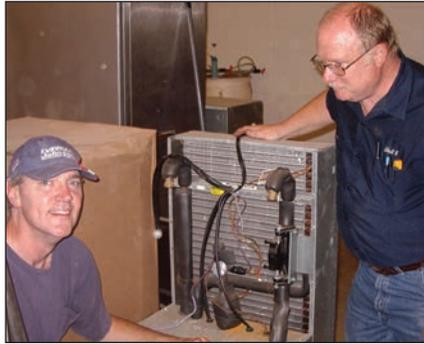
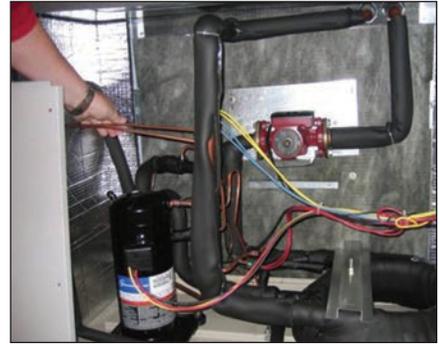
Figure 3 demonstrates equipment designs that are simple and relatively easy to service because of accessibility. Technicians Carl Foeller and Bill Thomas, who according to Monahan are “...great technicians and very smart,” view the core refrigeration package (compressor, water coil, air coil and pump) of a vertical unit that can be easily removed from the cabinet. If major service is required the package is replaced and the problem unit can be serviced at the maintenance shop. Figure 3 also illustrates the interior arrangement of a vertical classroom unit with ample access room for primary components. Figure 4 shows the complex proprietary controls for a dual capacity water-to-air heat pump that would likely incite Monahan’s ire. Figure 4 also demonstrates the difficulty of servicing units located in ceiling spaces.

Figure 3: Service-friendly heat pump package (left). Classroom unit with room for service (right).

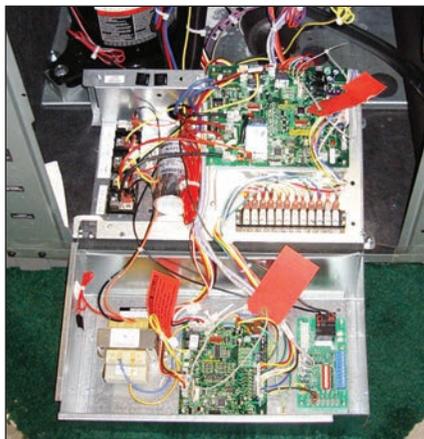
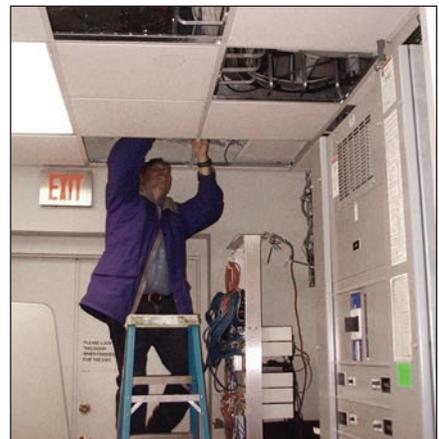
Figure 4: Control circuits for "advanced" heat pump. Unit in difficult-to-service location.

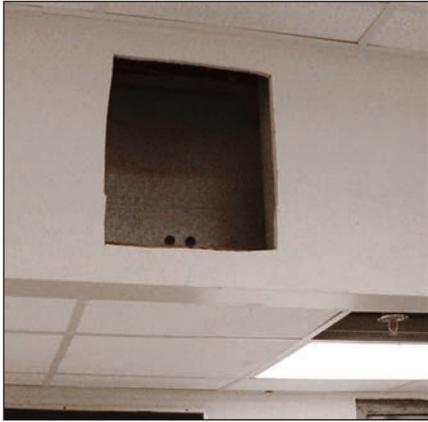
Figure 5 demonstrates one of the necessary solutions to problems that result when maintenance is not a primary design consideration. A heat pump was installed in a confined space above a lighting fixture and sprinkler pipe. This prevented access to the side panel when the fan motor failed. Motor replacement necessitated removal of the entire unit. When the motor failed again a few years later, Basinger cut out the drywall blocking the panel access. "They could hang a picture over the hole if it bothers someone, but they were happy the unit was repaired quickly."

Figure 5: A solution for lack of service access to problematic fan motor.

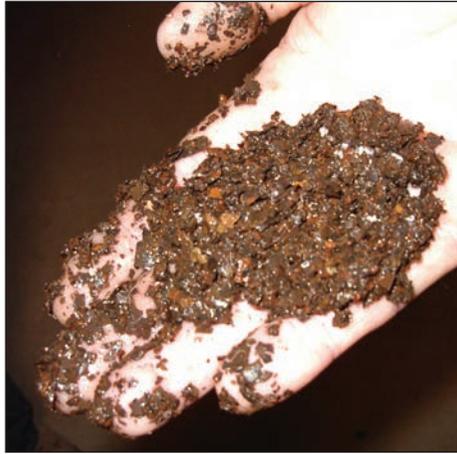
Figure 6: Results of failure to maintain water chemistry in two steel pipe building loops.

Results presented in a previous article⁴ indicate only one of the 14 variable speed pump drives (VSDs) observed during the project was functioning properly. *Figure 6* includes pho-

tos that provide some insight into a possible reason for this result. The photo on the left was taken at a site in which the interior piping was a combination of PVC, steel, and copper. PVC tees regularly cracked at the mechanical copper connection and piping sections in which failure occurred could not be isolated. Maintenance personnel were preoccupied with keeping the system operating and were not able to keep up with the constant need for chemical treatment. The photo on the right demonstrates a plugged 0.5 in. (13 mm) hose connection at an office. The owners were not aware that water chemistry maintenance was required. At both sites it is likely that ports to differential pressure sensors for the VSDs were also plugged.

- Minimum clearance specifications accommodate proper unit servicing is essential;
- Water treatment is necessary to minimize blockage of heat exchangers and water lines;
- Isolation valves are needed to clean strainers without draining the system; and
- Custom air filters for some equipment is an unnecessary expense.

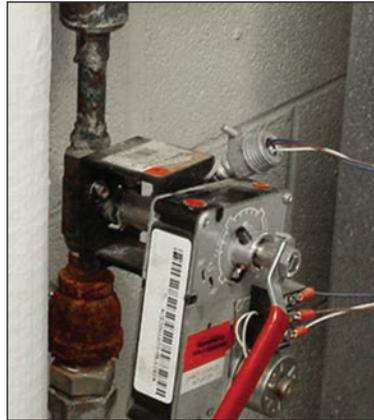
A third system with a variable speed drive experienced frequent heat pumps trip outs. Investigation revealed the supply pipe diameter to each heat pump was reduced to accommodate smaller control valves as shown in *Figure 8*. The problem was mitigated when the full line size piping and valves were installed.

Figure 8: Reduced line size control valve caused flow problems.

• Care should be taken in specifying and approving equipment and components to avoid unnecessary flow restrictions in the piping systems.
